Building Inspection Report

1234 Main Street

Inspection Date:
May 11, 2010

Report Number:
20100511-M1

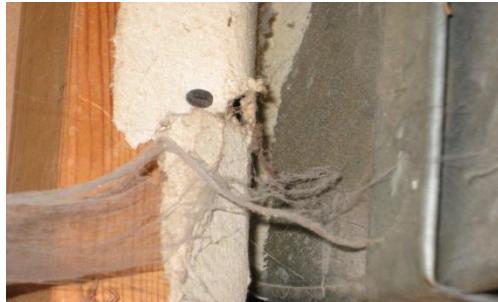
- Safety Issue:** Asbestos covering present where hot air supply passes through wood framed wall. This is a common installation in homes of this age. Recommend this be removed by a qualified HVAC contractor.

Asbestos covering noted on supply heat duct

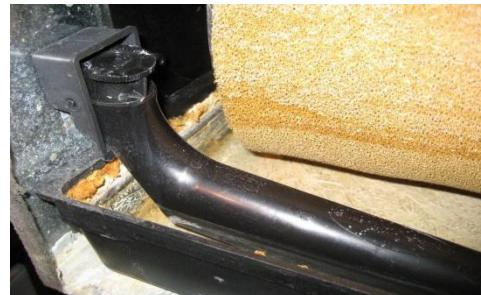
- **Repair:** The humidifier has lacked maintenance. Cleaning and repairs should be undertaken. Watch out for humidifier leaks into the furnace where costly (and hidden) damage can occur.

Furnace Humidifier requires cleaning

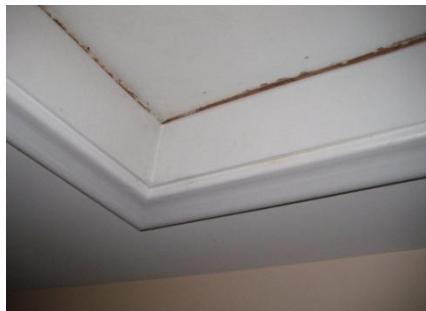
Install Weather-Strip on Attic Hatch

- **Repair:** Insulation should be evened out.
- **Improve:** The attic access hatch should be better insulated and hatch cover should have weather – stripping installed to seal the cover.

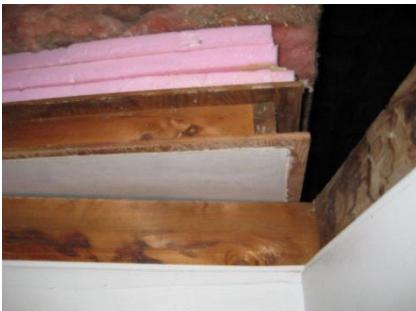
Improve insulation on hatch cover

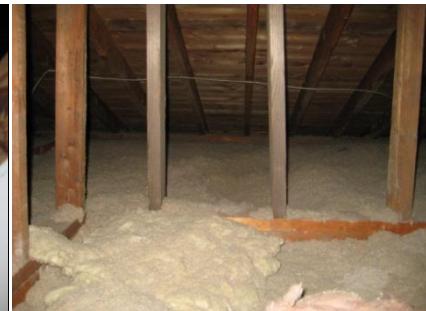
Even out insulation in attic

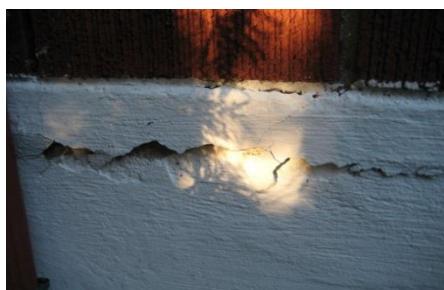
- **Improve:** Parging (concrete stucco coating) of the exterior of the foundation is desirable to improve the appearance and the weather tightness of the exterior of the home. This would seal some minor cracks in the parging observed in several locations.

Parging cracks North West Corner

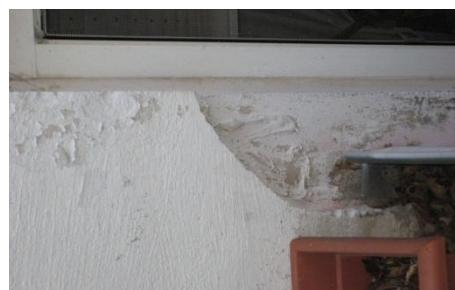
- **Repair:** Parging is damaged around the front basement window and should be repaired to ensure there is no further delaminating of the parging on the foundation wall. (See Structural Section for photos)

Missing Parging South (front) wall

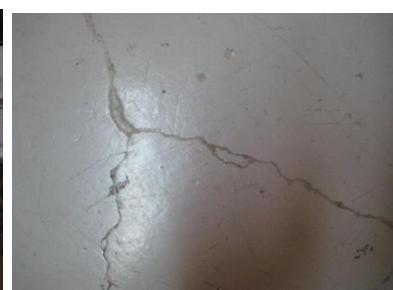
- **Monitor:** Common minor curing cracks were observed in the basement concrete floor. Cracks of this type should be watched for any sign of additional movement and if they exceed 10mm should be repaired.

Minor common cracks basement floor

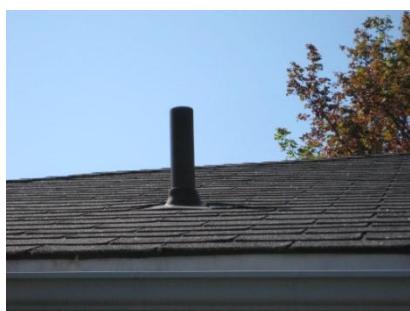
Recommended Vent Stack configuration

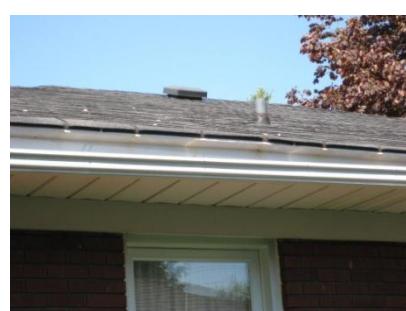
- **Monitor:** The presence of sufficient venting for the waste piping in the basement bathroom is suspect.
- **Repair:** The vent stack that penetrates the roof should extend at least 24inches above the roof and should be at least 3 inches in diameter. Extending the vent stack will ensure proper venting in winter when there is snow accumulation.

Current Vent Stack too short

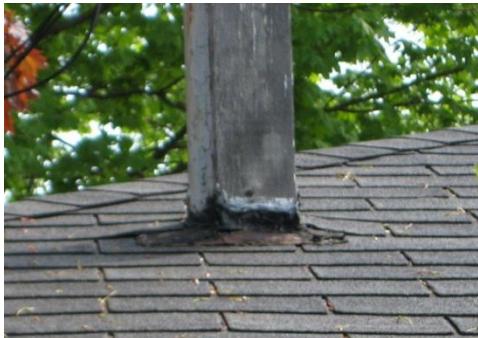
- **Repair:** The flashing at the hydro mast should be caulked to avoid leaks and recommend painting wooden mast to preserve the wood and avoid any rot.

Hydro mast requires caulking at roof and painting of wooden mast.

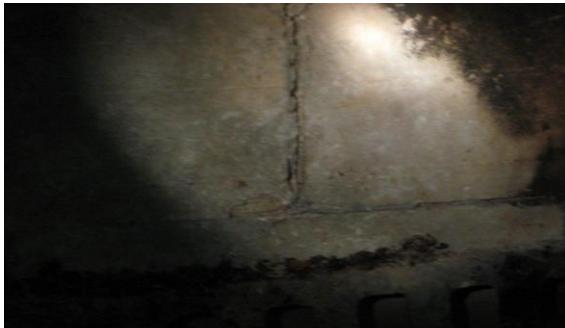
- **Repair:** The in the living room fireplace chimney should be inspected and cleaned prior to operation.
- **Safety Issue:** Install CO (Carbon Monoxide) in room with fireplace.
- **Repair, Safety Issue:** The rear wall of the in the living room fireplace firebox has minor cracks and is missing mortar in some joints. This should be repaired for improved safety.

Crack in firebrick and mortar joints should be repaired.

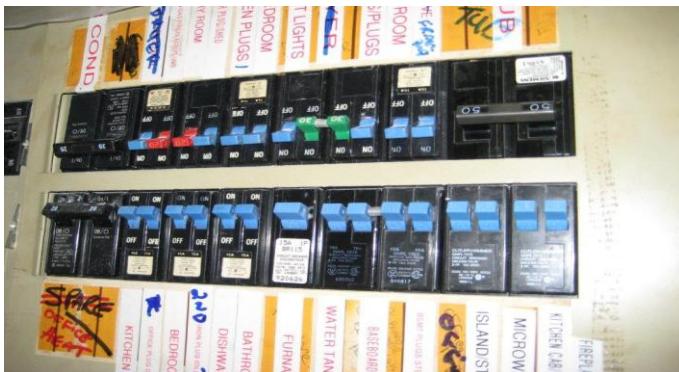
Main hydro panel is well labeled. Panel is full, and expansion would require a pony panel installation.
